TECHNICAL REPORT REMR-CO-3

CASE HISTORIES OF CORPS BREAKWATER
AND JETTY STRUCTURES

Report 7

NEW ENGLAND DIVISION

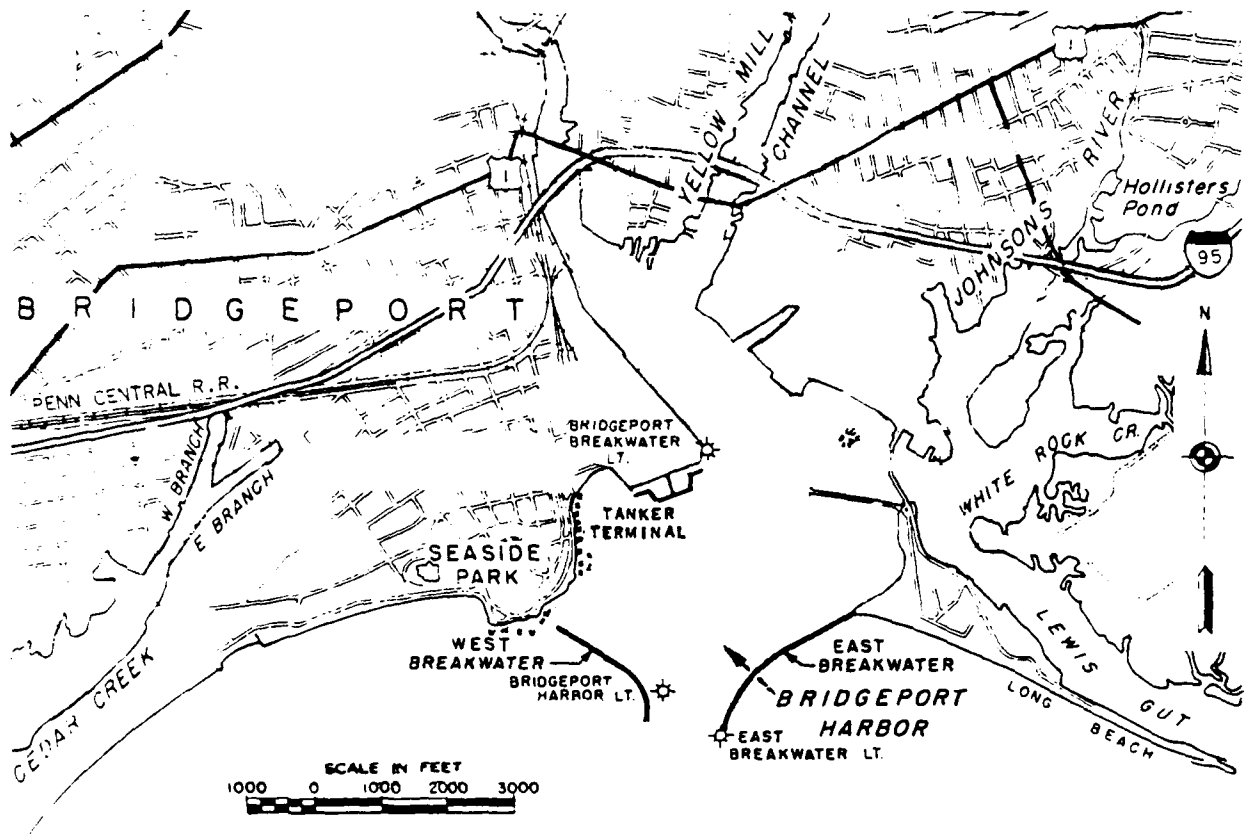
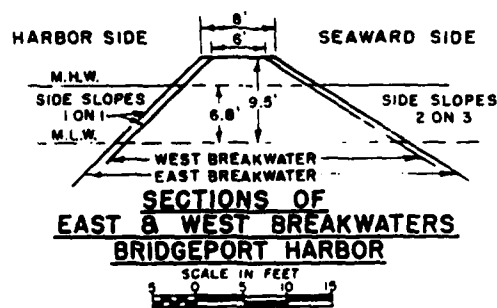
Figure 50. Breakwaters at Bridgeport Harbor, Conn.

1941	The east breakwater was repaired using 2,650 tons of stone for a total cost of \$13,000.
1960- 1978	Several visual inspections were made, and the breakwaters were generally in good condition. By 1978 the inspectors recommended the structures be considered for future maintenance.
1986	Present conditions of the breakwaters are not known.

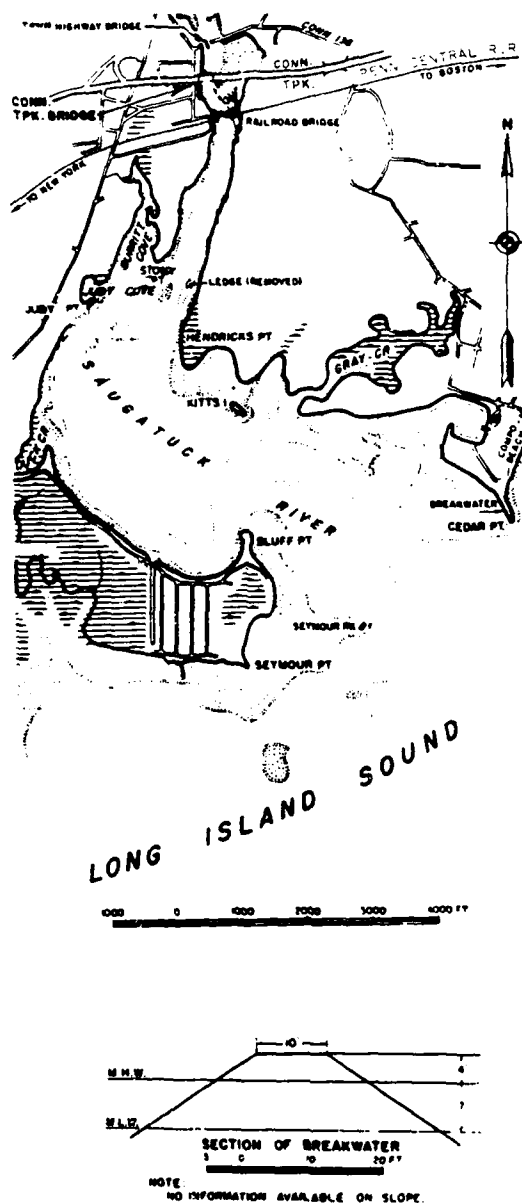
Date(s)	Construction and Rehabilitation History
1896	A 600-ft-long rubble-mound breakwater was constructed on the east side of the Saugatuck River's mouth (Figure 53). The crown elevation and width were +11 ft mhw and 10 ft, respectively.
1986	The breakwater has no known repair history, and its present condition is unknown.

Figure 53. Cedar Point breakwater, mouth of the Saugatuck River, Conn.

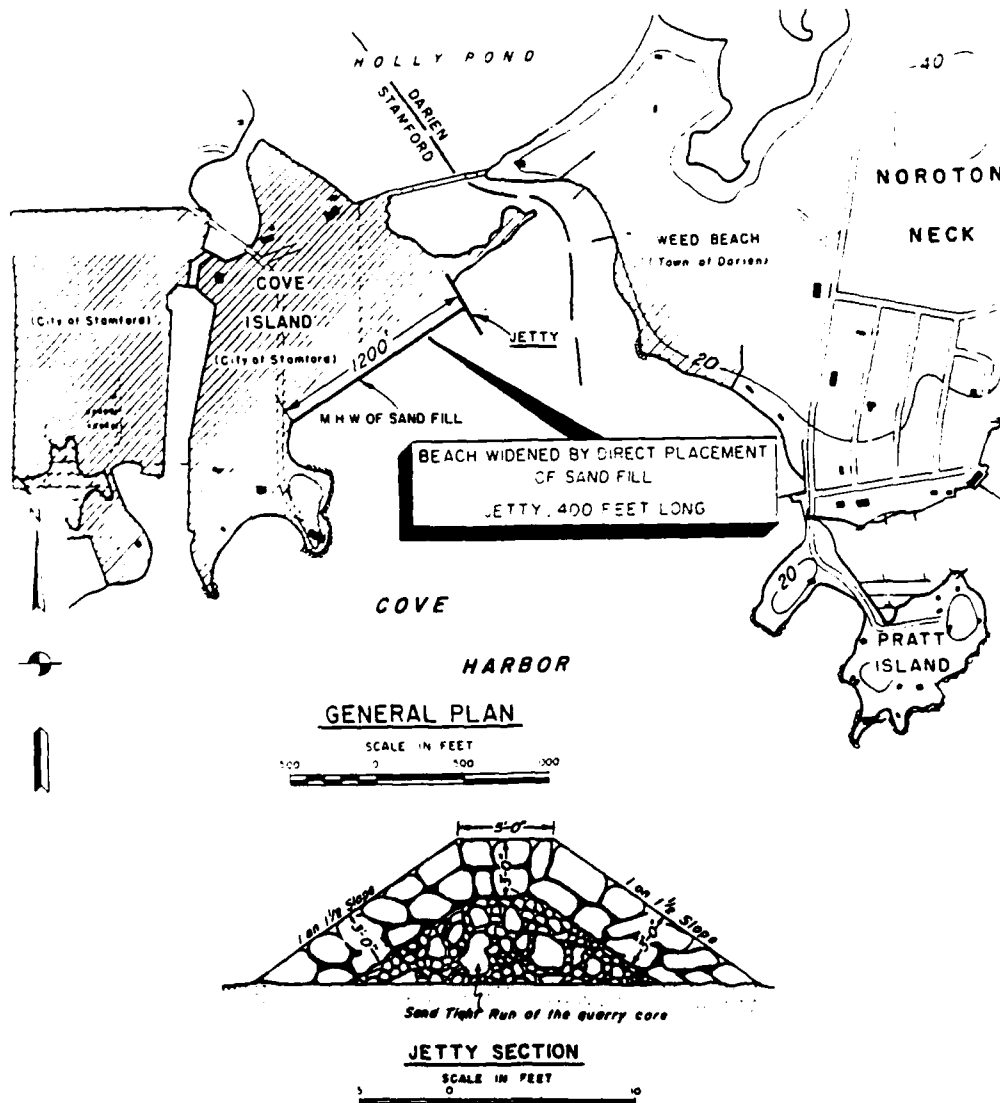
Date(s)	Construction and Rehabilitation History
1958	A 400-ft-long jetty was constructed on the east side of Cove Island (Figure 54). The jetty consisted of a +10 ft crown elevation, a 5-ft crown width, 1V:1.5H side slopes, a sand-tight run of quarry core, and a 3-ft-thick double layer of cover stone. The State of Connecticut, which constructed the jetty, was reimbursed by the Federal government for one-third of the project cost.
1986	The jetty has no known repair history, and its present condition is unknown.

Figure 54. Cove Harbor Jetty, Cove Island, Conn.

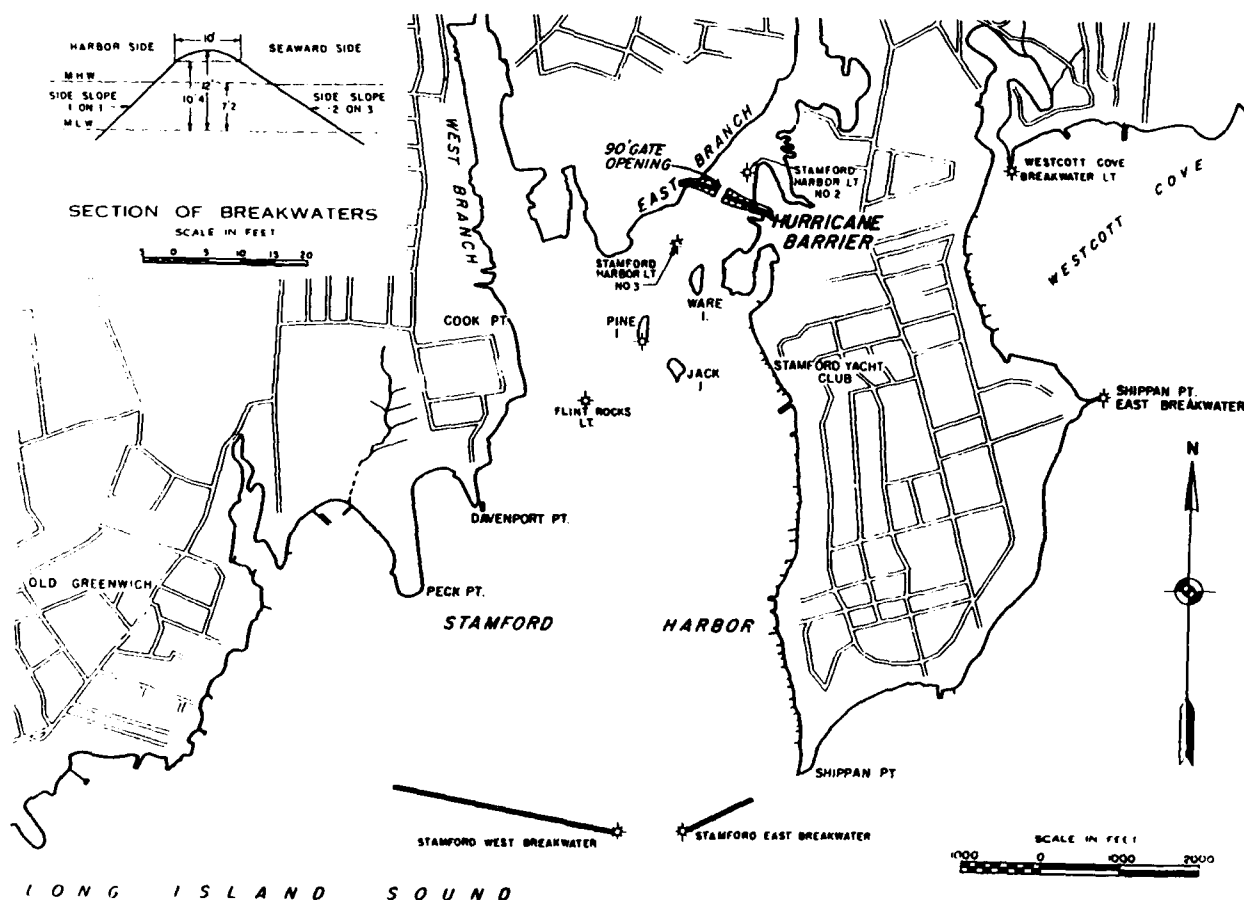
Date(s)	Construction and Rehabilitation History
1940-1941	The east and west breakwaters (Figure 55) were constructed to lengths of 1,200 and 2,900 ft, respectively, using 40,100 and 118,100 tons of stone, respectively. The cross section had a maximum crown elevation of +12 ft mlw, a 10-ft crown width at +10.4 ft mlw, and slopes of 1V:1H and 1V:1.5H on the harbor and sea sides, respectively. The total construction cost was \$398,900.
1960-1977	Visual inspections indicate the breakwaters were in fair to good condition.
1986	Present conditions of the breakwaters are not known.

Figure 55. Plan view of breakwaters at Stamford Harbor, Conn.
